Safety Bulletin 01 of 2019

Small Craft - Throw Bag Rescue Line Failures

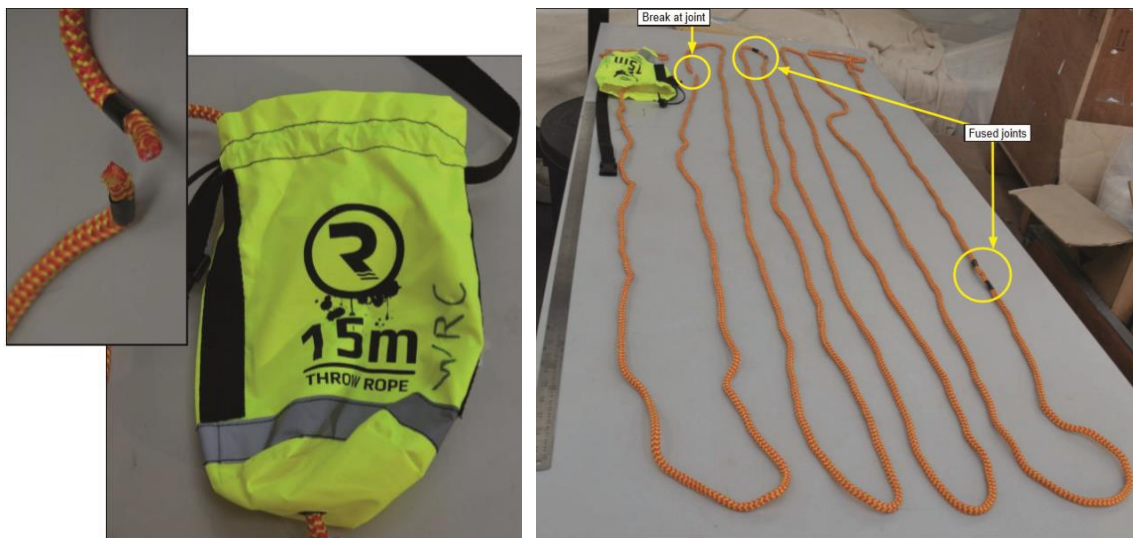
This Safety Bulletin is issued following the failure of a throw bag rescue line, at a join in the line, during a recovery exercise in the UK. As a result, a Bulletin and Incident report have been issued by the Marine Accident Investigation Branch (MAIB). It is strongly recommended that all local users of such equipment carry out the checks contained in the Bulletin. Links to the Bulletin and the full MAIB report are below.

RIBER, and several other suppliers of throw bag rescue lines, import the complete manufactured product pre-branded with their company's logo. The foreign suppliers identified so far assemble the throw bags using components from further suppliers. As the rope used for rescue lines in throw bags is not classified as lifesaving or safety equipment, there is no requirement for it to conform to any recognised safety or quality standards.

- The entire length of the rescue line should be examined for joins or other discontinuities. This can best be done by feeling along the length of the line with bare hands to identify rough patches or lumps.
- Any knots, splices or other methods of securing the ends of the line to handles, quoits or other parts of the equipment should also be checked for integrity.
- The throw bag should be inspected and tried at regular intervals and repacked according to the manufacturer's instructions, as otherwise the line may not deploy freely from the bag when required.

Any throw bag rescue lines found to have joins or discontinuities should be removed from service and the original manufacturer /supplier informed.
